CHANSON, H. (1998). "Use of Rubber Dams for Flood Mitigation in Hong Kong. Discussion." *Jl of Irrigation and Drainage Engrg.*, ASCE, Vol. 124, No. 3, pp. 181-182 (ISSN 0733-9437).

USE OF RUBBER DAMS FOR FLOOD MITIGATION IN HONG KONG^A

Discussion by Hubert CHANSON^b

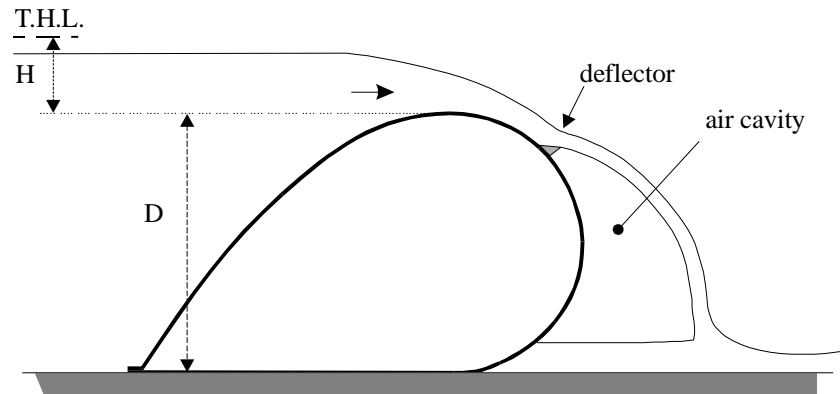
Fig. 10 - Sketch of overflow above a rubber dam equipped with a deflector (i.e. fin)

Nappe adherence vibrations can be eliminated by ventilating the underside of the nappe and by deflecting the nappe off the rubber dam wall (fig. 10). In practice the later method is nowadays commonly used. The deflector is designed to project the nappe away from the membrane and to prevent the nappe re-attachment on the membrane. The optimum characteristics of deflector were investigated by the discussor (CHANSON 1996).

During a small overflow event above an inflated rubber dam equipped with a deflector, an air cavity forms between the membrane and the thin nappe of water. Free-surface undulations and fluttering instabilities might occur if the air cavity is not or poorly ventilated (i.e. Kelvin-Helmholtz instability). Kelvin-Helmholtz instabilities can be controlled or

prevented by two means : nappe ventilation and splitters¹. Usually splitters are installed along the deflector at regular intervals to divide the nappe in several narrower nappes, creating numerous gaps in the nappe allowing for the passage of air.
